**Foundation Evaluation Report  
for  
PROPERTY ADDRESS  
Houston, Texas 77089**

**August 30, 2012**

**Charles J. Jenkins, P.E.**

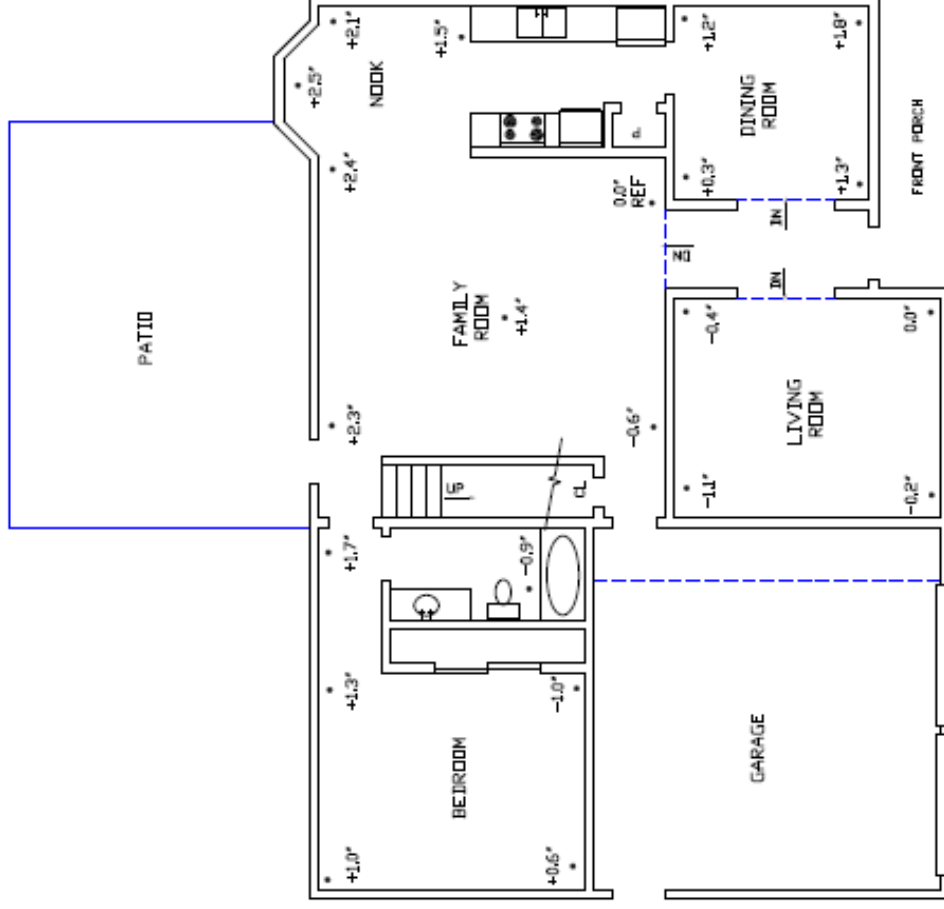
## ELEVATION SURVEY

A topographical survey was performed of the floors using an electronic manometer, called a "Zip-Level®". This device functions in a manner similar to a "water level" and has a digital display of measurements taken, thus providing an indication of how flat and level the floors are. Elevations were measured in relation to a zero reference elevation (0.0") placed at the middle of the doorway from the raised foyer to the family room. Measured elevations in the house were adjusted for changes in floor coverings. Elevations were not measured in the garage. Elevation readings ranged from the +2.5" to -1.1". A copy of the floor plan of the house, showing measured elevations, is provided in Appendix A to this report.

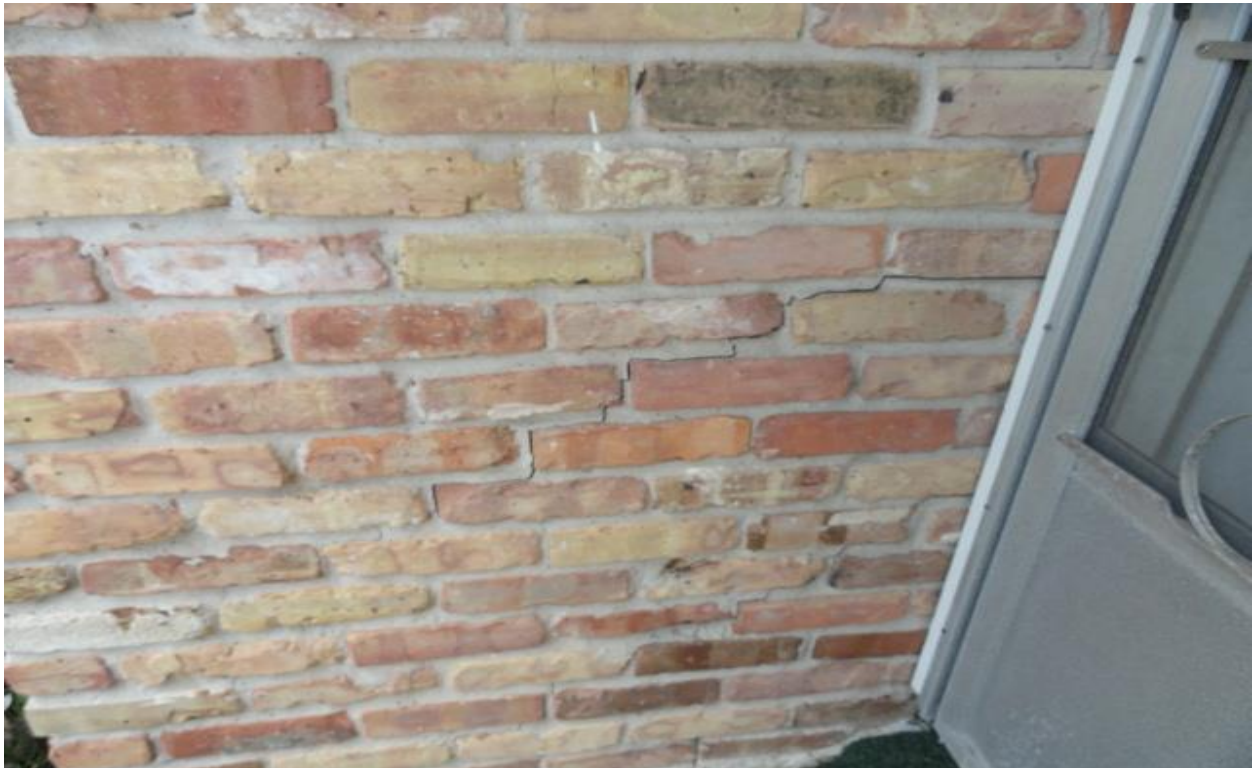
Exterior walls of the residence were covered with brick veneer and vinyl siding. Vinyl siding was serviceable, with no significant damage or distortions apparent. Diagonal tuck point repair was found in brick veneer on the left side of the house. The filled crack was wider at the top than at the bottom, indicating that it had been filled prior to foundation work being performed. Two diagonal cracks, hairline to 3/32" in width, were found in brick of the wall to the left of the front door. A diagonal brick crack was found at the bottom left of the family room window. Brick was separated from the frame of the family room window, on the top and both sides. The separation along the top was about 1/8", with side separations ranging from about 1/16" to 1/8". A vertical crack about 1/16" in width was found at the right corner of the rear wall of the nook bay window, with a hairline vertical crack at the left corner of the same wall.

Photo # 2      Cracks in brick to left of front entry door

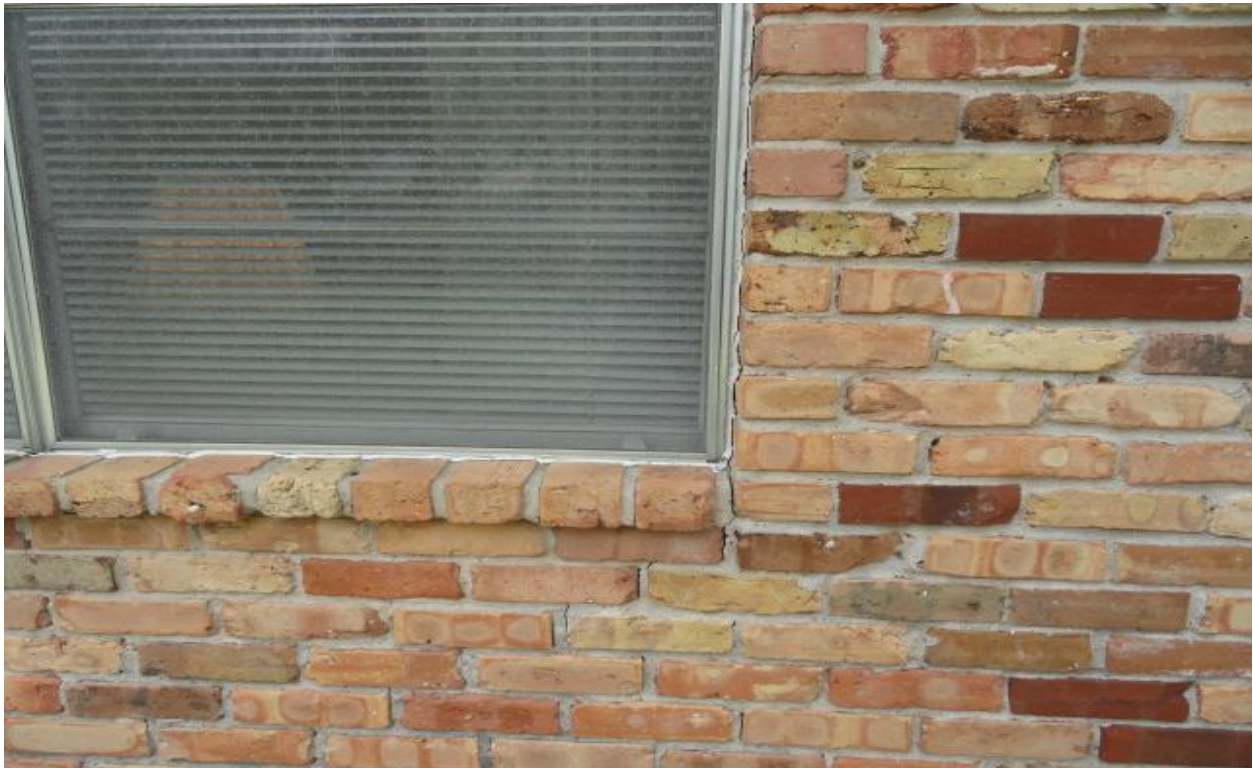
Photo # 6      Crack at bottom left of family room window, with caulk separation at brick

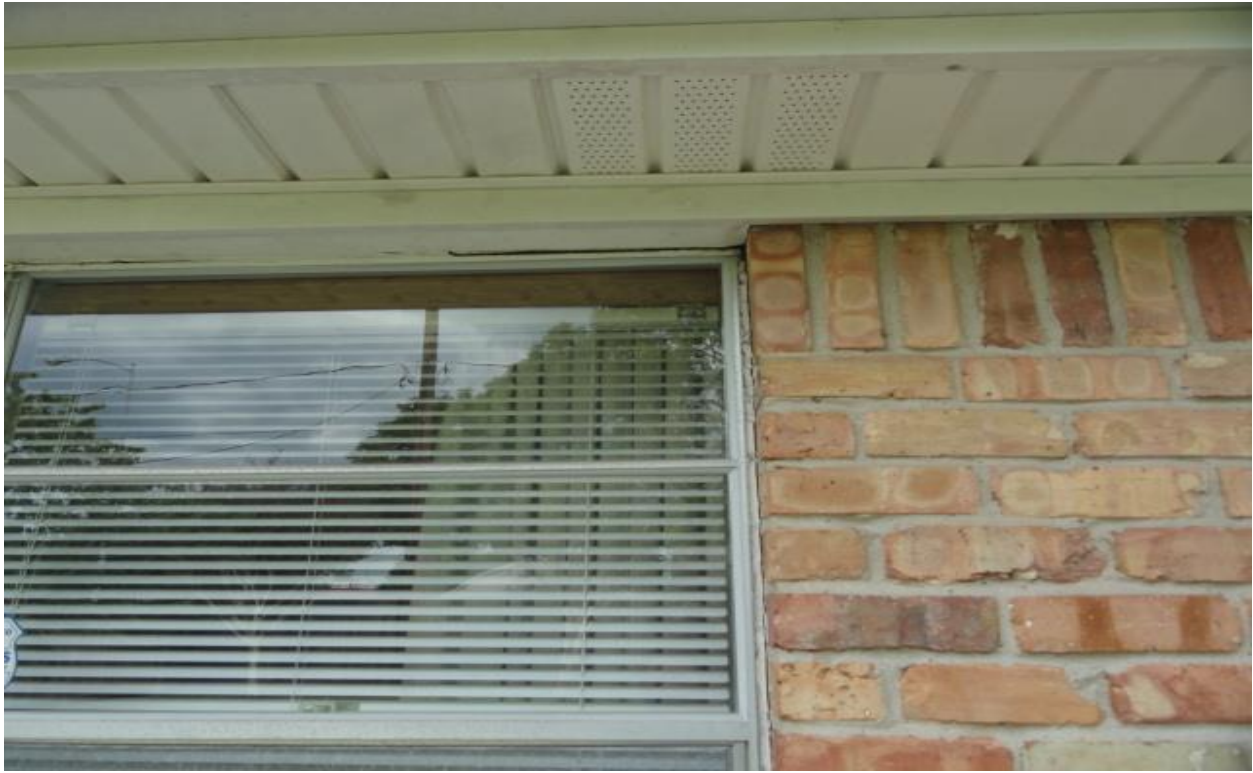
Photo # 7 Separation between top trim and top of window frame

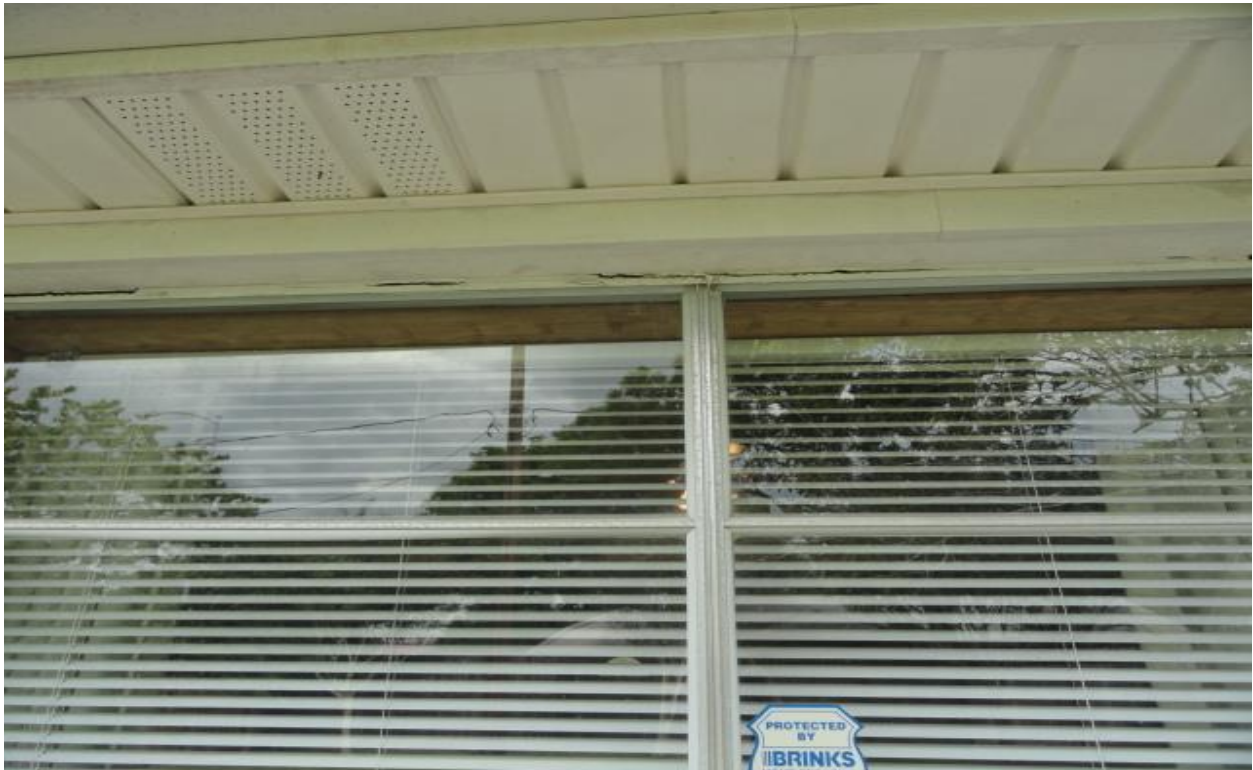
Photo # 8 Separation of top trim at top of window

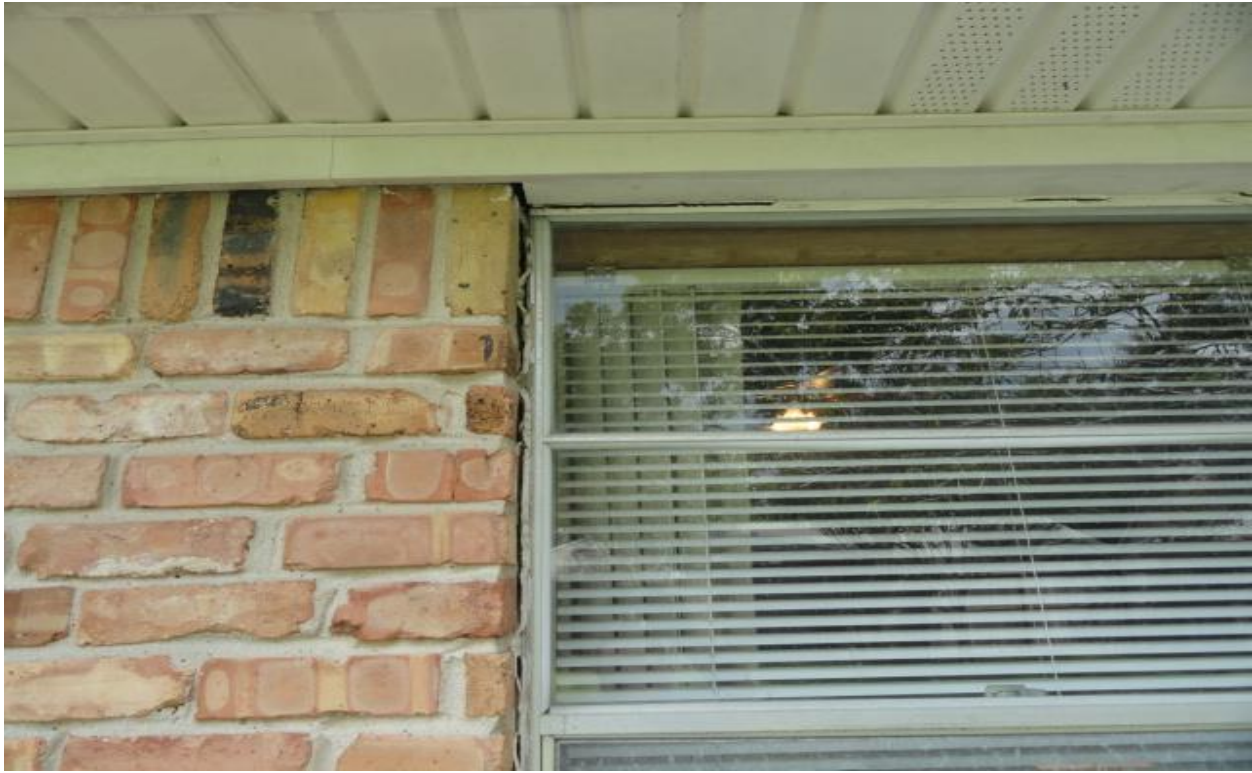
Photo # 9 Separation between brick and right side of family window frame

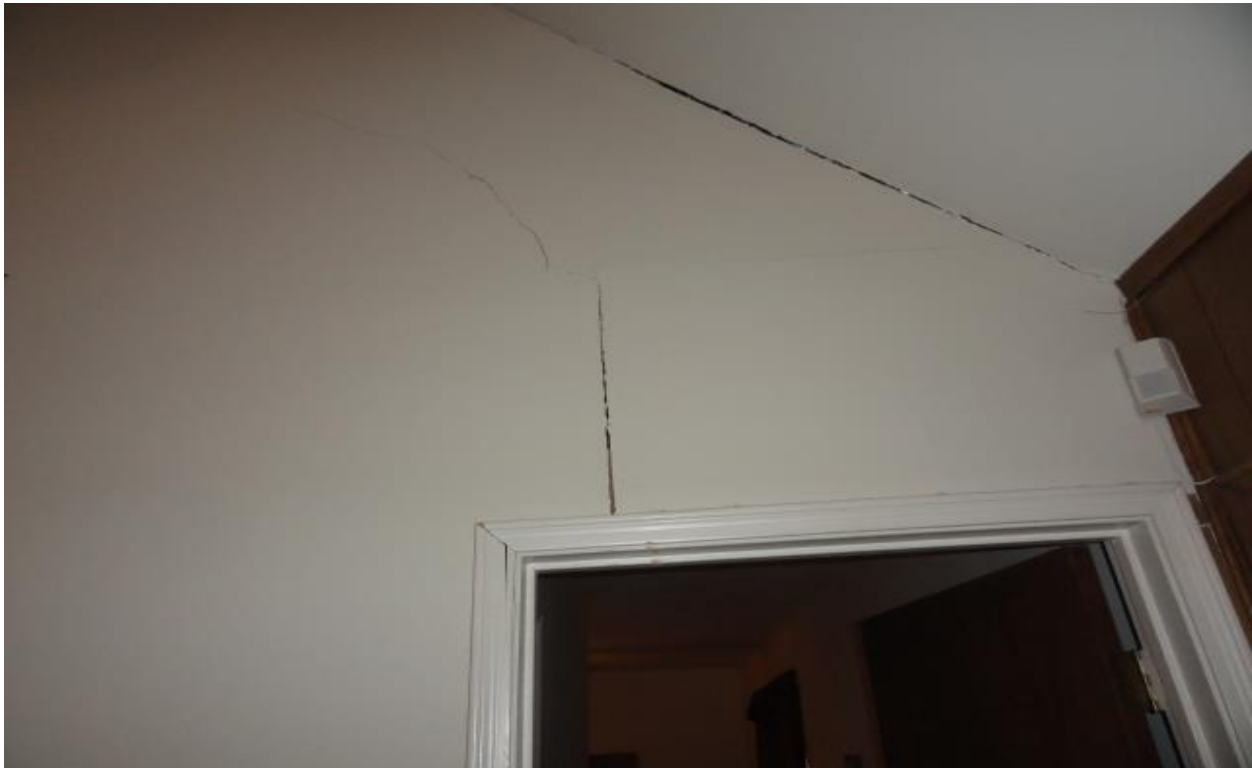
- A sheetrock crack extended across the kitchen ceiling at the rear of the cabinets
- In the family room,
  - A vertical crack, with a diagonal extension toward the front of the house, was found over the door to the master bedroom

Photo # 10 Cracks above door to master bedroom

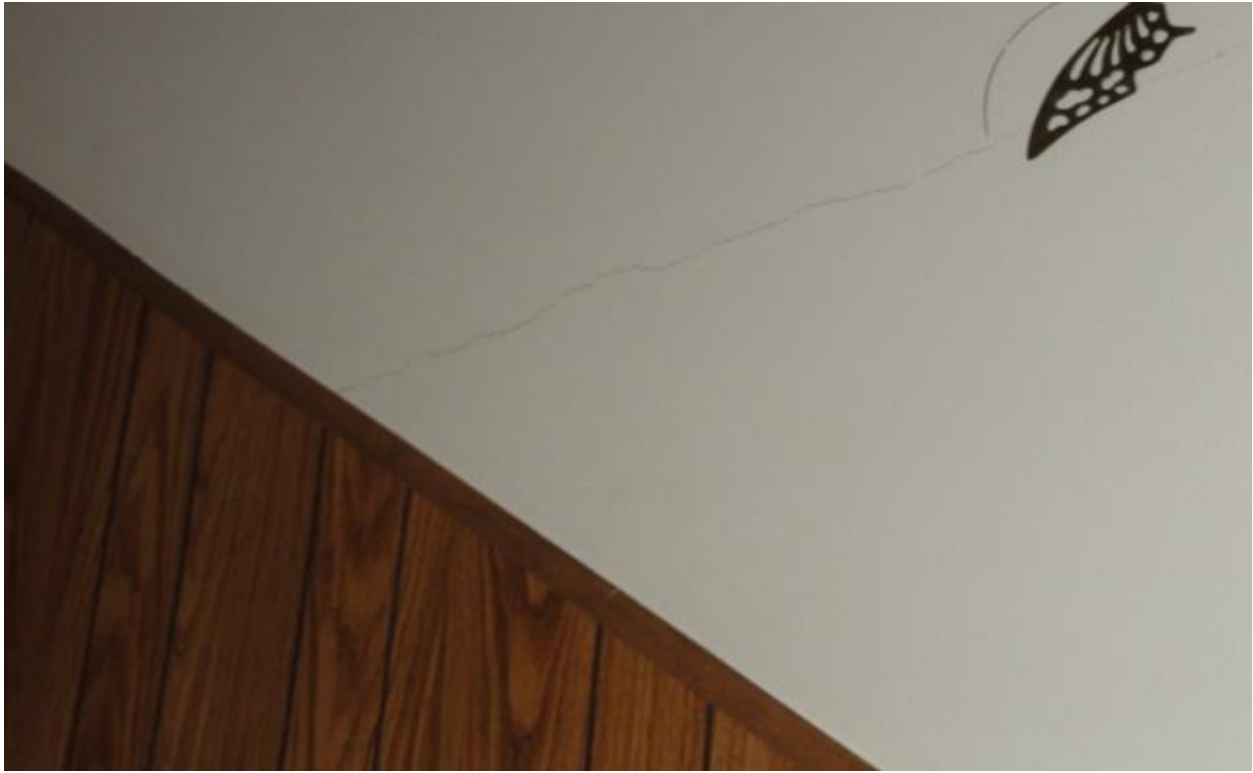
- A horizontal sheetrock crack was found in the left wall, about 1/2 way up the stairs to the second floor
  - A horizontal sheetrock crack was found about 1/3 of the distance from the ceiling to the ground floor

Photo # 11      Crack in wall to left of stair, toward front of master bedroom door

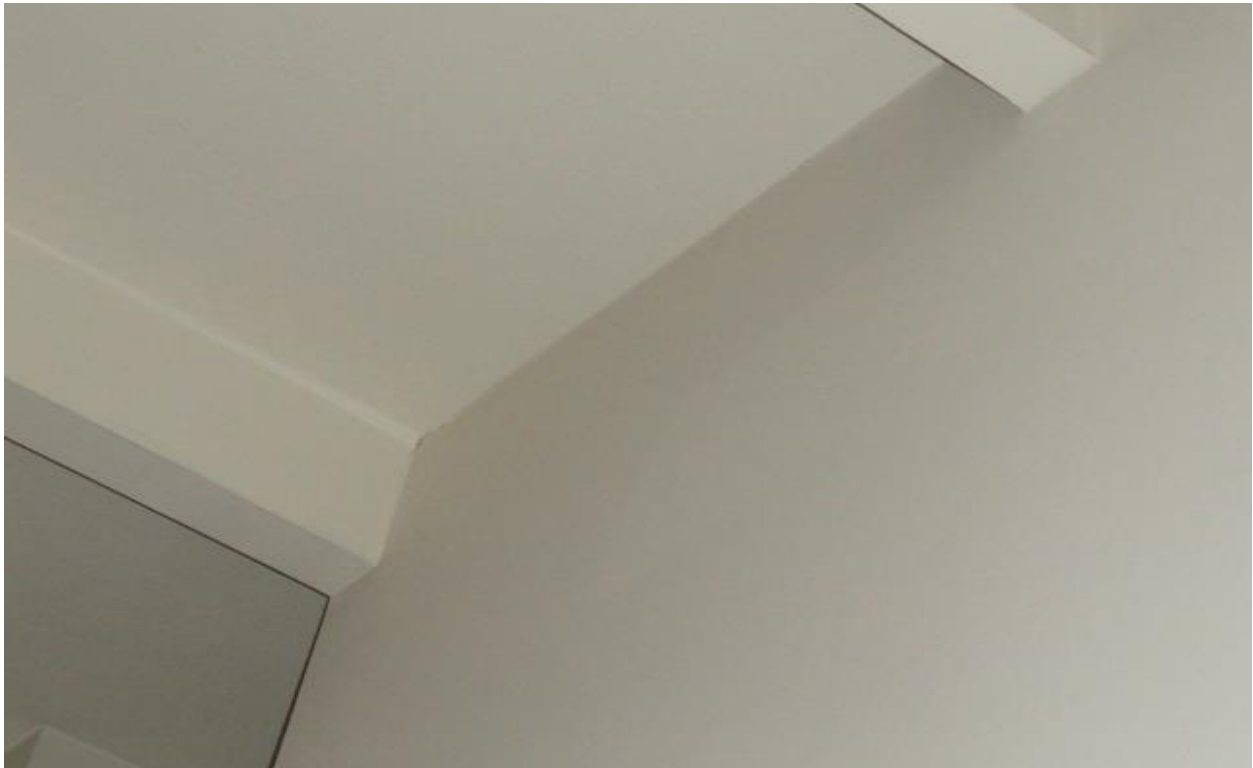
- A horizontal sheetrock crack extended along the left wall, between the two beams of the ceiling
  - A horizontal crack, with a vertical extension, was found in the front wall, at the corner where the wall transitions to the second floor landing

Photo # 12      Crack between beams, left side of ceiling in family room

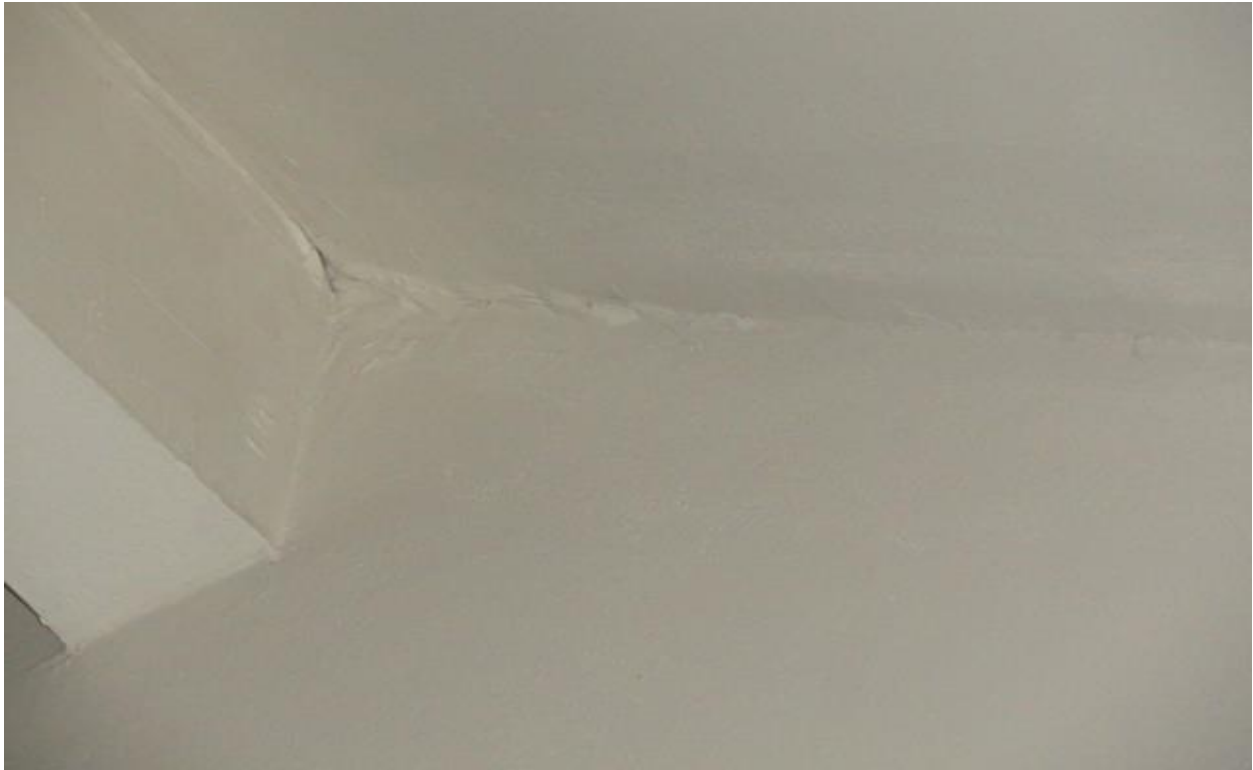
Photo # 13      Warped tape at left front corner of family room

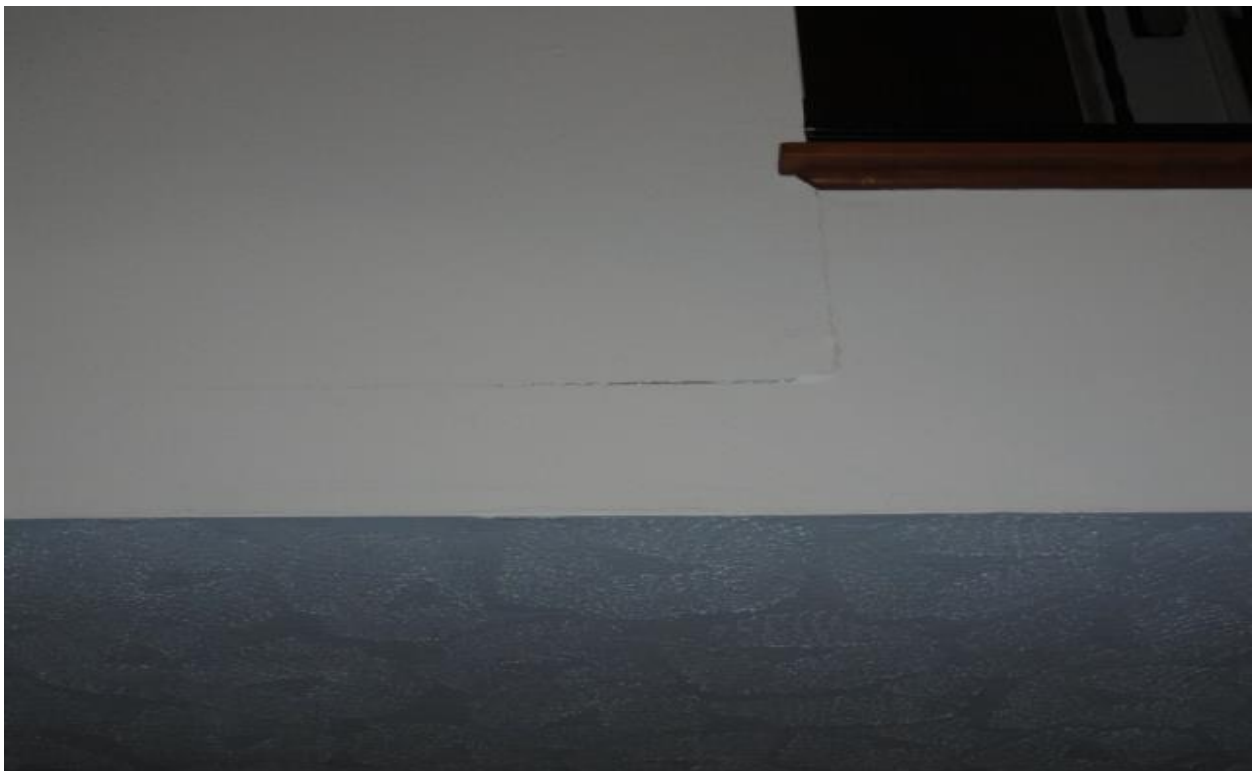
Photo # 14      Cracks in front wall under second floor landing, at floor/wall transition

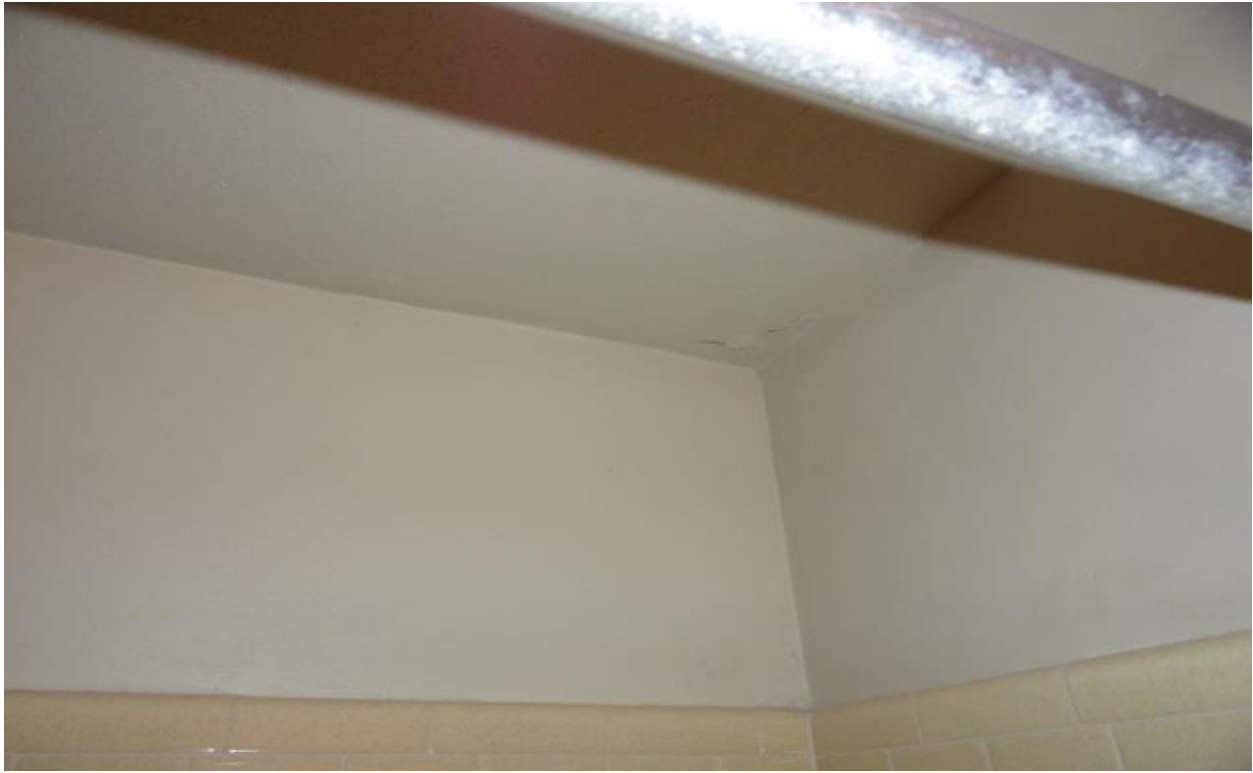
Photo # 15 Torn sheetrock at ceiling over master bath tub

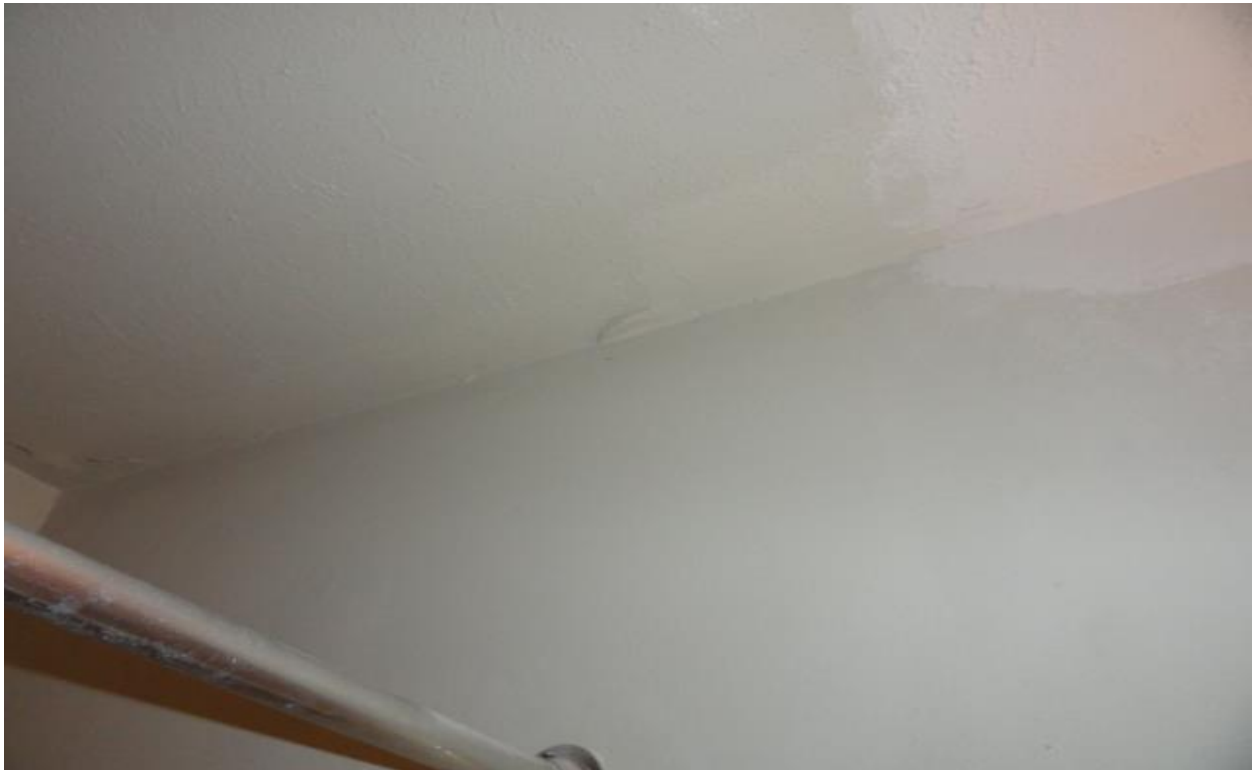
Photo # 16 Cracking and repair at wall/ceiling over bathtub

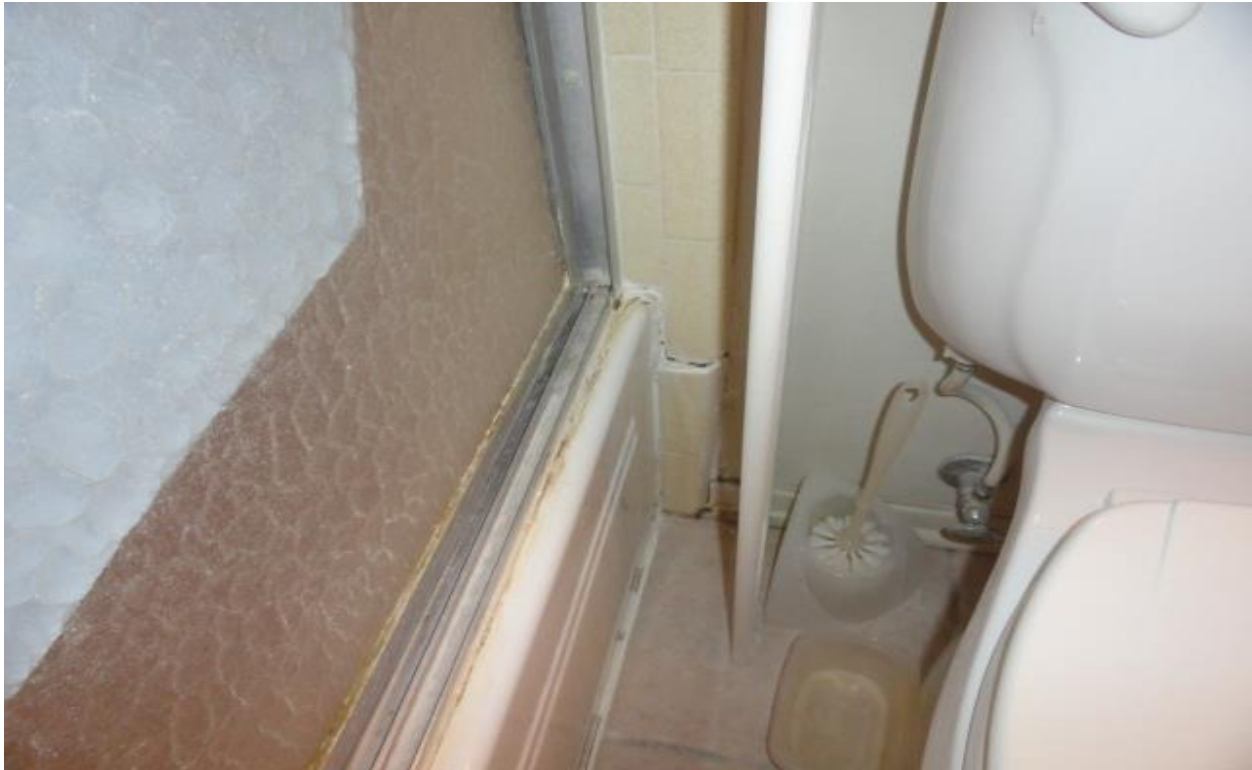
- Warped sheetrock tape was found at the right rear corner, with a crack along the ceiling
  - Tile at the bottom of the walls at the head and foot of the bathtub, along the outside of the tub, was cracked and buckled

Photo # 17 Displaced tile at head of master bath tub

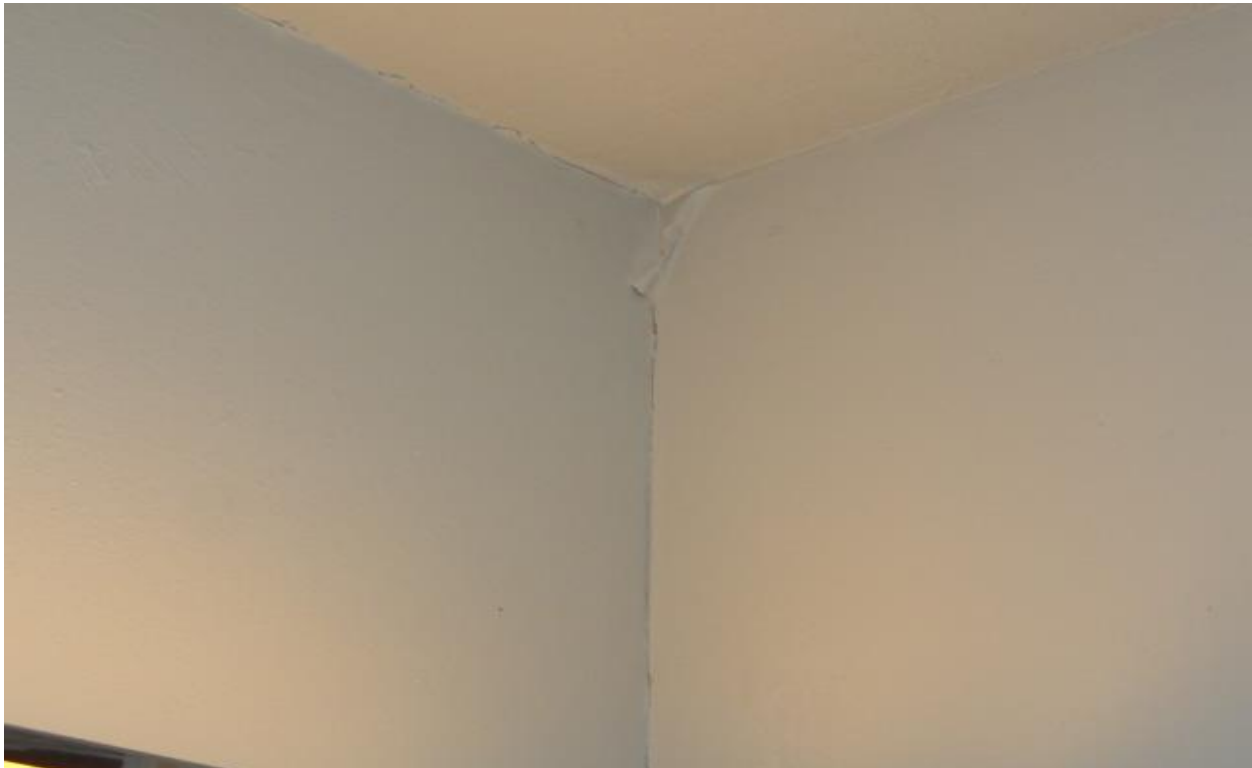
Photo # 18 Sheetrock damage in master bedroom

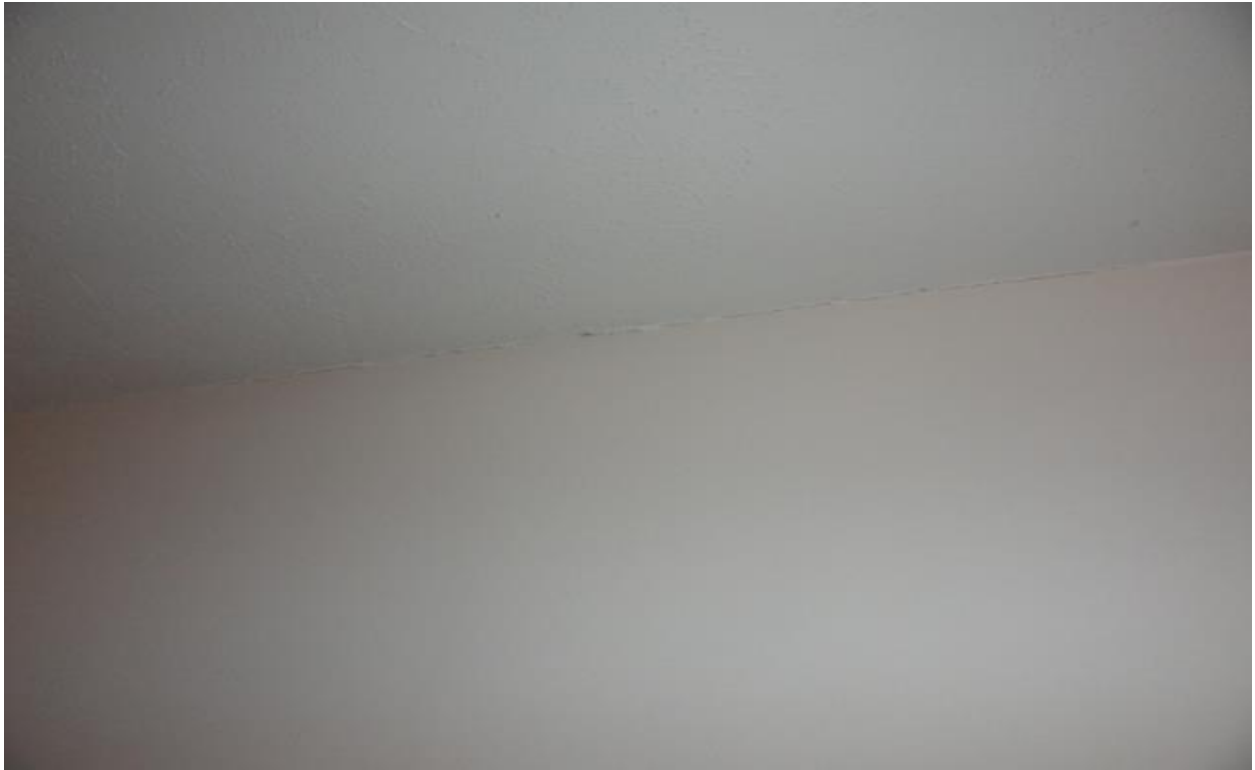
Photo # 19     Cracks along ceiling, common throughout

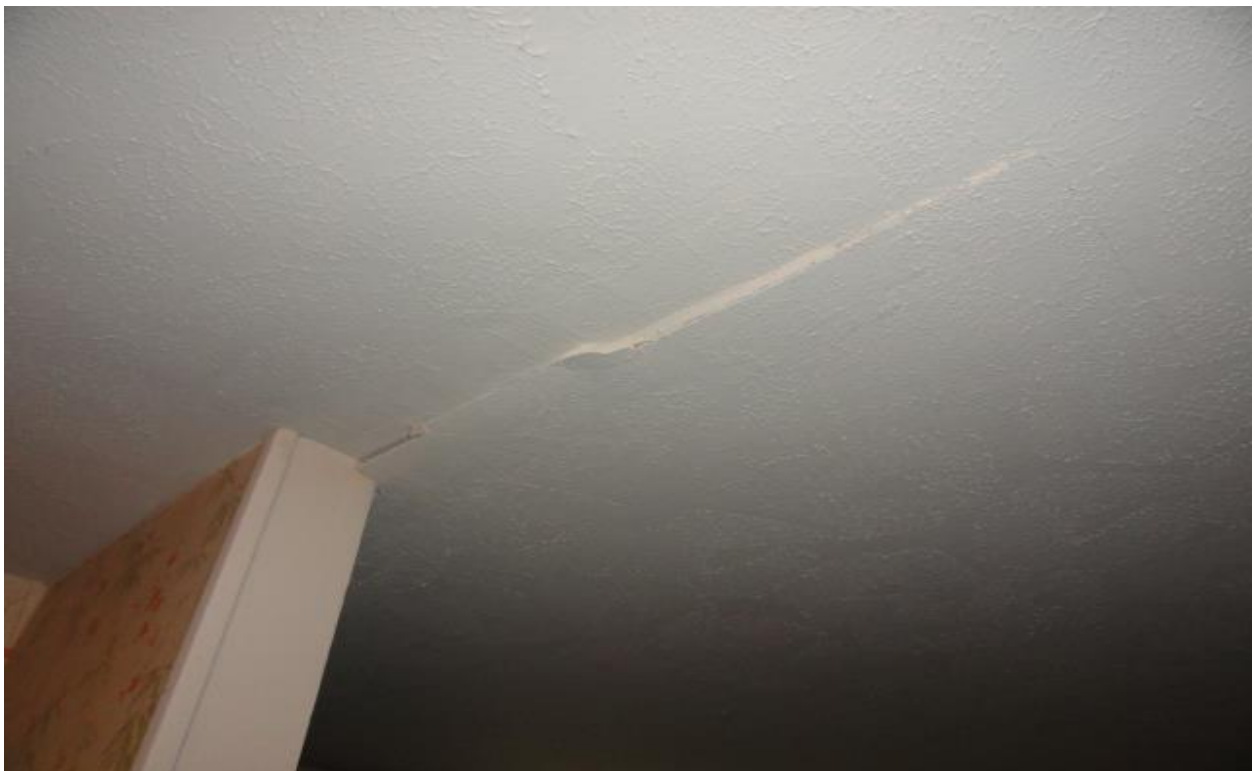
- Sheetrock of the ceiling at the front of the doorway to the living room had dropped down about 1/2"
- In the living room,
  - The walls at the left front corner were separated about 1/2" at the ceiling, with the crack narrowing as it approached the floor

Photo # 20     Fallen sheetrock in living room ceiling at foyer

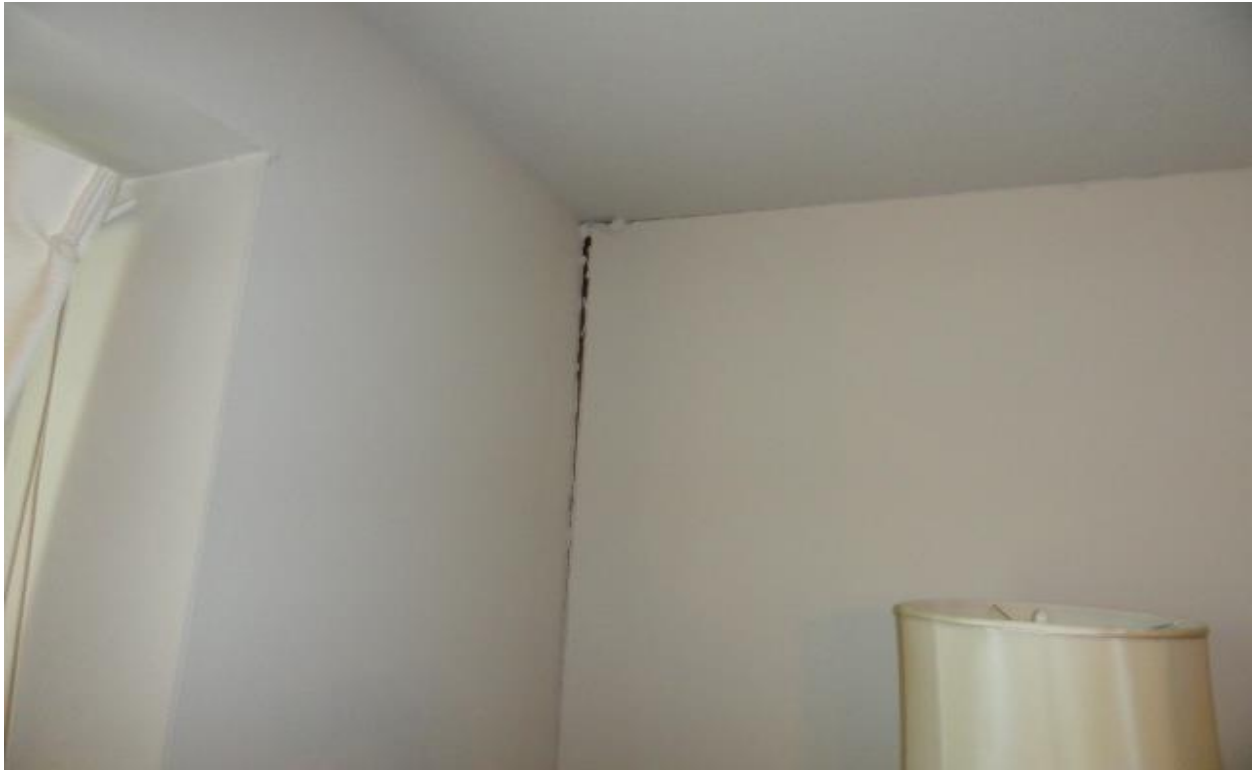
Photo # 21 Separation between front and left wall in living room

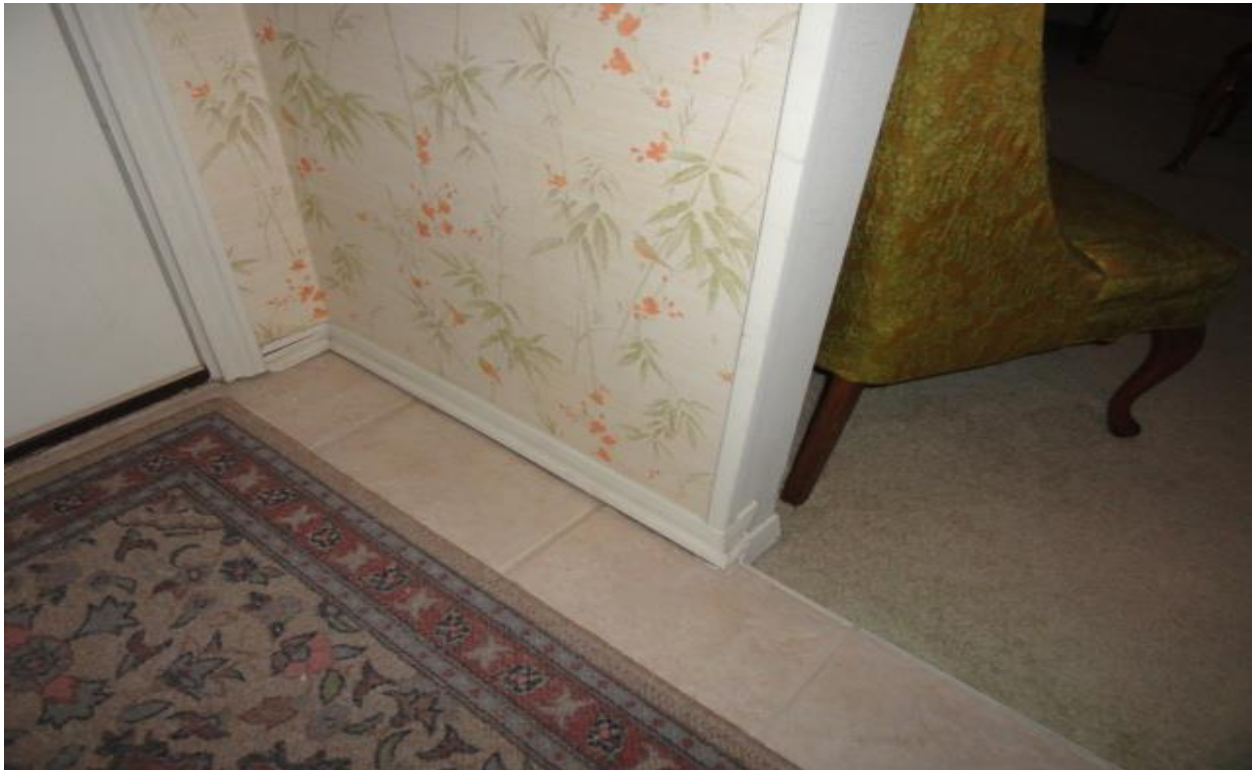
- In the foyer,
  - The wall to the left front was separated from the floor about 1/2"
  - The wall to the right rear was separated from the floor about 1/2"

Photo # 22 Separation of wall at left front of foyer from floor

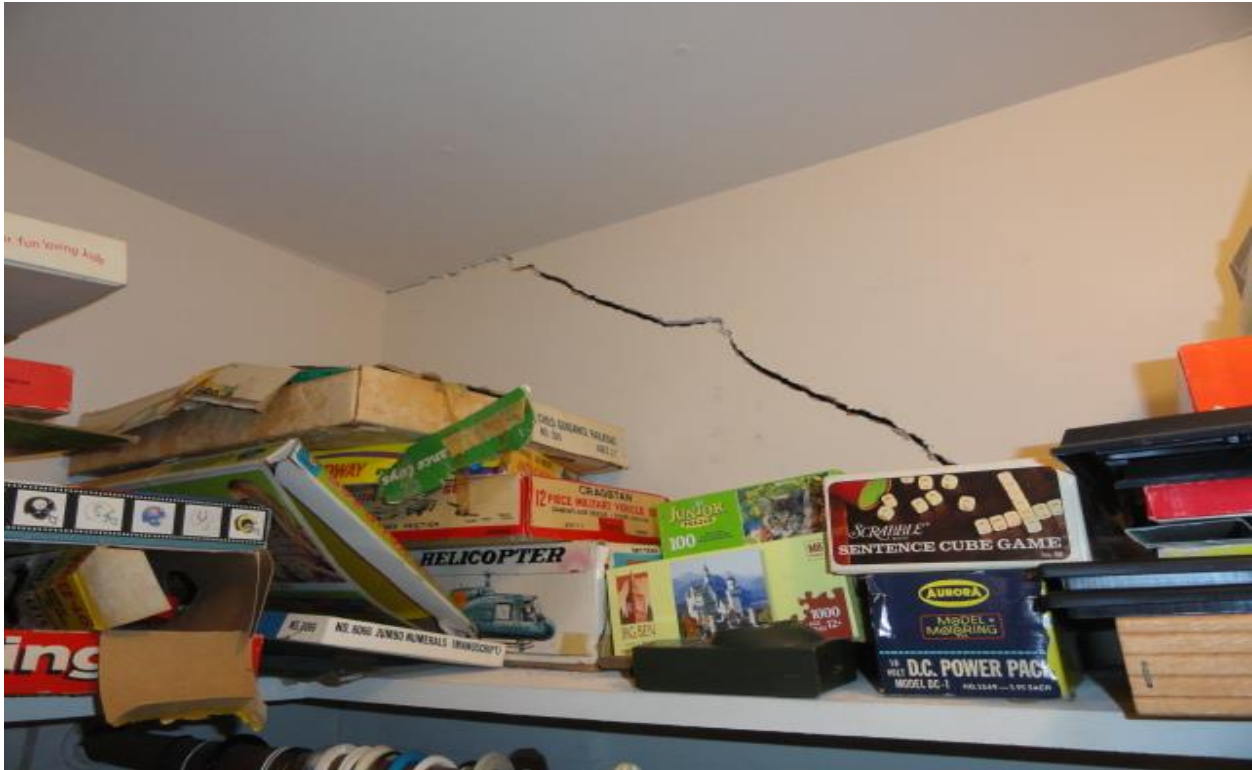
- A 1/4" diagonal crack was found in the right wall of the closet
  - A vertical crack was found over the rear of the closet door
  - The left wall was separated from the front wall at the left front

Photo # 23      Diagonal crack in wall of bedroom closet, second floor

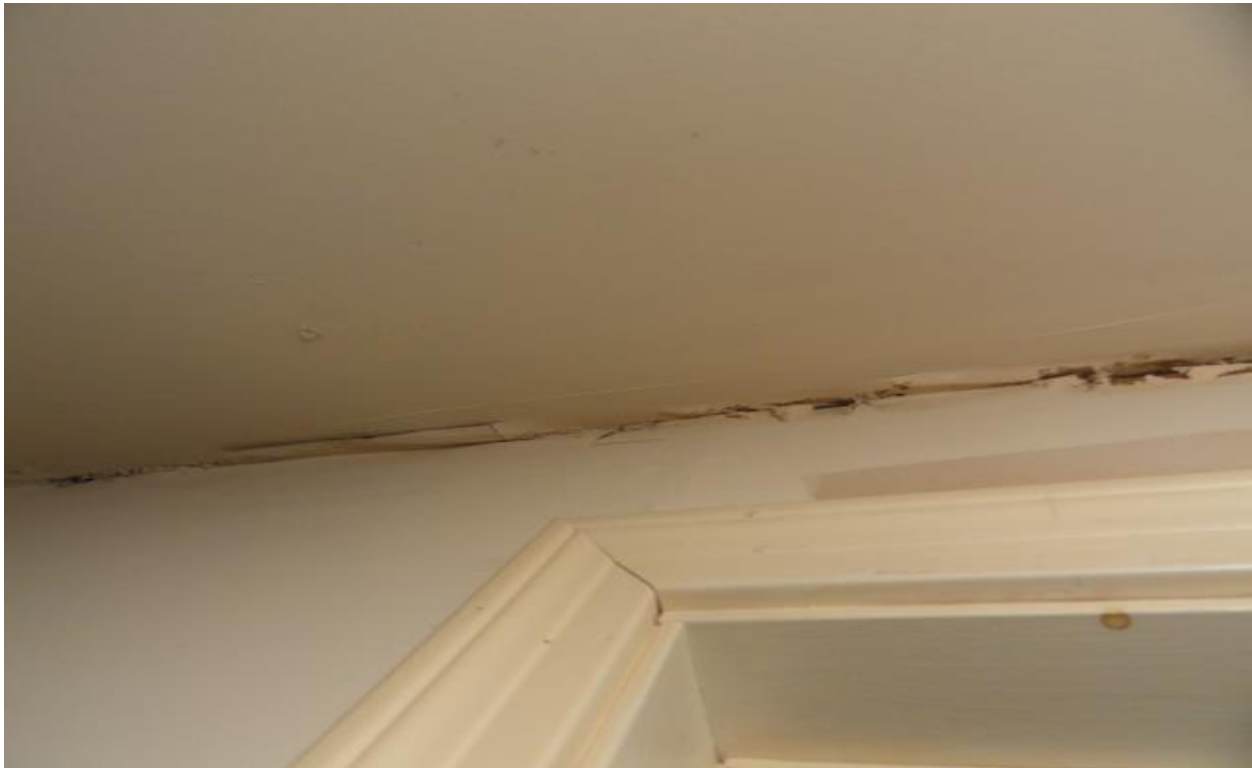
Photo # 24      Cracking along ceiling/wall in front closet of upstairs left bedroom

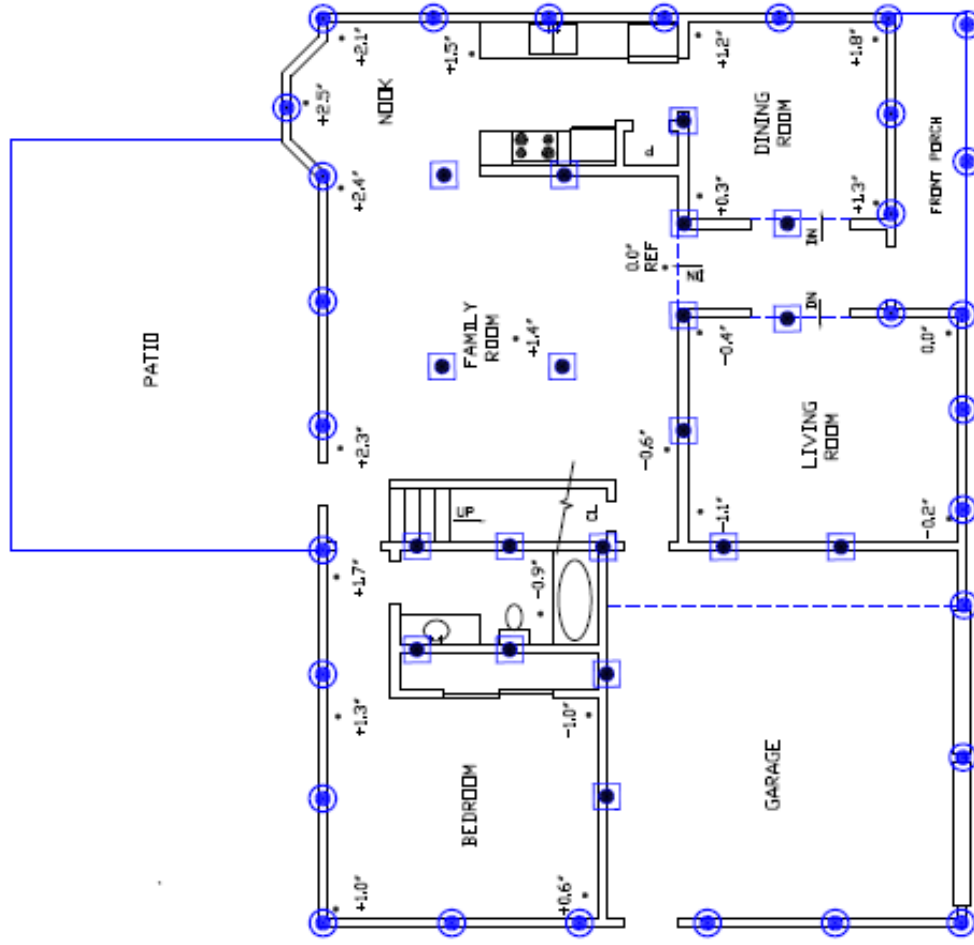
### **PROPOSED PILING LAYOUT FOR FOUNDATION STABILIZATION**

Based on the conditions observed, as described above, it is our opinion that the foundation of this residence has experienced differential movement substantially in excess of that considered reasonable and expected. This movement appears to have been limited, primarily, to the interior of the house because of previous stabilization of the perimeter. As a result, no additional stabilization of the perimeter of the house appears to be required. That said, the interior of the house does require stabilization, with some adjustment to return the ground level floors to a

reasonable degree of flat and level. To that end, a recommendation for such stabilization is provided in Appendix C.

Based on the above, it is recommended that recommended interior stabilization be performed using segmented pressed pilings, installed through tunnels excavated for that purpose. After pilings have been installed and the foundation has been adjusted to the degree feasible for this project, new sewer lines should be installed, using existing tunnels for that process. The new sewer lines should be suspended from the bottom of the slab and tested for leaks prior to back-filling the tunnels. Tunnels should then be back-filled using the same material that was excavated.
